ES_P89LPC903 Errata sheet P89LPC903 Rev. 02 — 4 May 2010

Info	Content
Keywords	P89LPC903 errata
Abstract	This errata sheet describes both the known functional problems and any deviations from the electrical specifications known at the release date of this document.
	Each deviation is assigned a number and its history is tracked in a table at the end of the document.

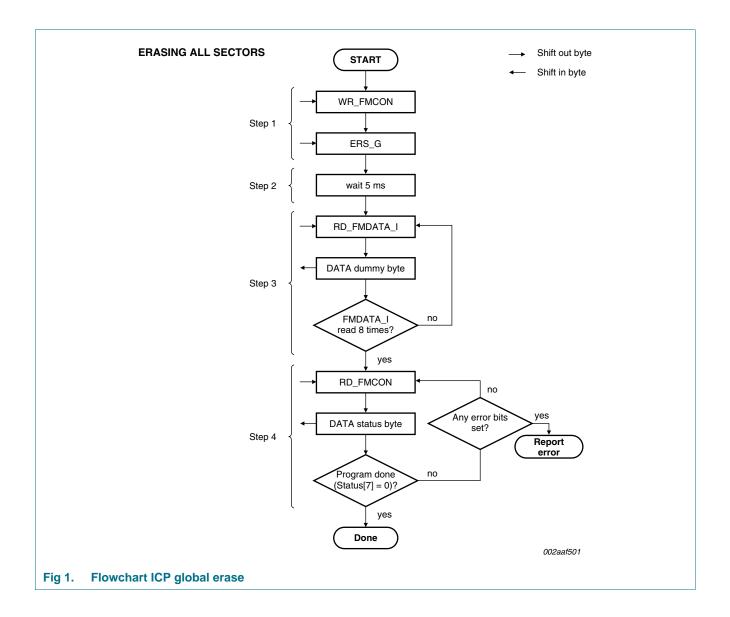
3.3 ICP.1: ICP Global Erase

The P89LPC903 can be programmed using ICP (In-Circuit Programming). One of the ICP functions is the Erase Global command, which will erase the entire chip including the security bytes and configuration information.

When giving the Erase Global command through the ICP interface the P89LPC903 will not clear the busy flag and stay busy forever.

The workaround can be done in four steps:

- Step 1: Shift out the WR_FMCON command followed by the Erase Global opcode.
- Step 2: Wait 5 ms.
- Step 3: Do 8 dummy reads with the RD_FMDATA_I command.
- Step 4: Read FMCON until the busy flag gets cleared.

Please also see Figure 1.
