## *Device Errata*

# **MPC801**

**Silicon Revision A.2 - Mask Set F87S**  
**May 18, 1998 (Version - 4)**

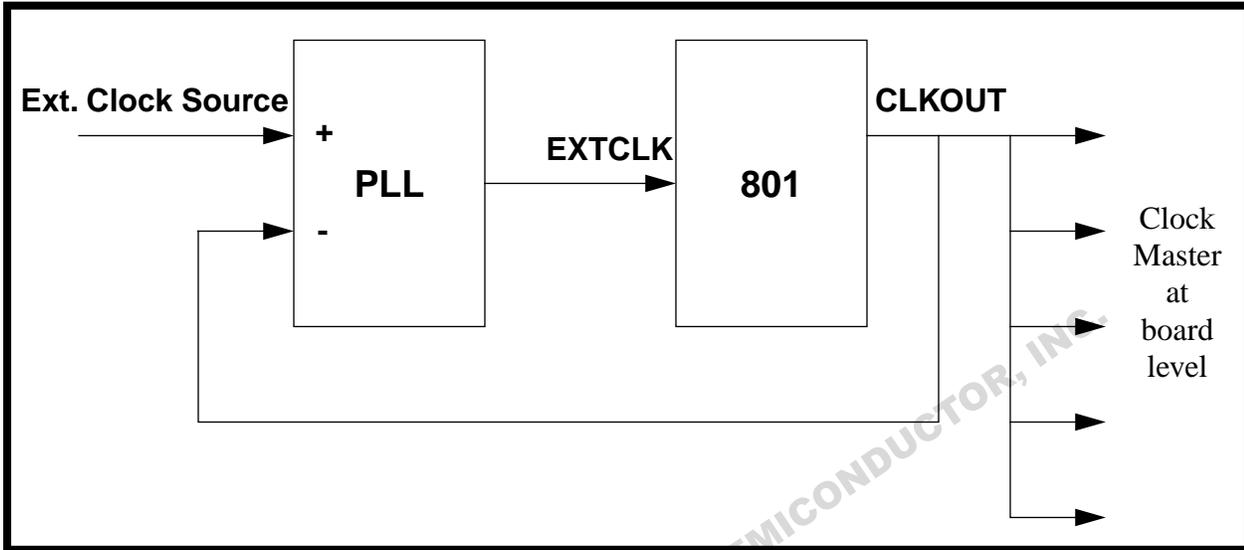
#### **G5. Potential problems caused by skew between EXTCLK and CLKOUT.**

The PLL of the MPC801 locks on the falling edge of the input clock EXTCLK. This will affect the skew between EXTCLK and CLKOUT at the rising edge. The skew is dependent on the duty cycle of the input clock (but for a 50% duty cycle will not exceed 2nS). This will affect synchronous designs where the same clock source is used as an input to EXTCLK, as well as to an external synchronous device (e.g. a peripheral or ASIC).

Case 2. Where it is necessary to synchronize an external master clock (e.g. from a backplane), an MPC801, and external peripherals, to allow data transfers in all three directions:

[NOTE: This workaround is a concept only. It has not been verified in hardware.]

Insert a PLL between the external master clock and the EXTCLK pin of the MPC801. Connect the phase comparison pin of the PLL to the CLKOUT pin of the MPC 801. Also use the CLKOUT signal as the reference clock for distribution to the local external peripherals.

**Important Note:** The PLL has to be capable of operating with a permanent offset of -2nS, therefore the range of lock should extend to about -4nS.

A diagram of this concept is given below:
