Device Errata for the MPC866 Family

This document details all known silicon errata for the MPC866, MPC859T, and MPC852T. [Table 1](#) provides a revision history for this document.

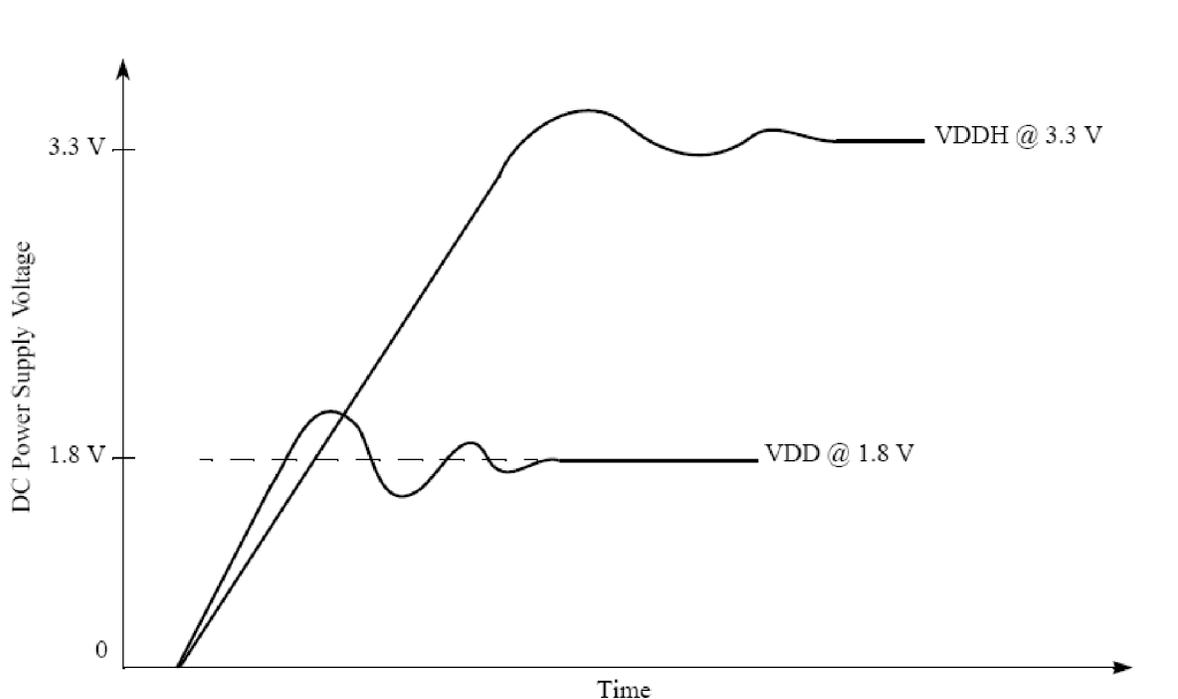
Figure 1. Power Supply Ramping

G14 Possible I/O glitches

If core supply voltage (VDDL) is below recommended operating conditions while I/O supply voltage (VDDH) is high during a power-on reset sequence, I/O pins (including those designated input only) might drive a value instead of being Hi-Z. This could confuse connected devices and, in turn, cause the PowerQUICC device to behave improperly. Affected pins include such interfaces as the communication parallel I/O, reset, address and data bus pins, and JTAG pins.

The value a pin may drive is random. As soon as core voltage has stabilized at its nominal level within recommended operating conditions, all pins will behave normally and the PowerQUICC will continue to function properly.

It is recommended that VDDL/VDDSYN be raised before or simultaneously with VDDH during the power-on reset sequence; that is, while $VDDH \leq$ recommended operating condition for VDDL/VDDSYN during ramp of all voltages, it should be ensured that $VDDL/VDDSYN >=$ VDDH at all times.

If the power supply design cannot be altered as recommended, then any logic connected to the PowerQUICC which may react or be affected in an undesirable manner by unexpected low or high signal values during power ramp up should be appropriately secured in the design. Using SDRAM as an example, it is usually sufficient to connect the CKE input to PORESET. The practice of tying CKE high may not be safe and may lead to an unrecoverable system state.
