Errata

MVPX2ERR/D
Rev. D, 3/2002

MVP X2 Multiprocessor
Evaluation System
Errata

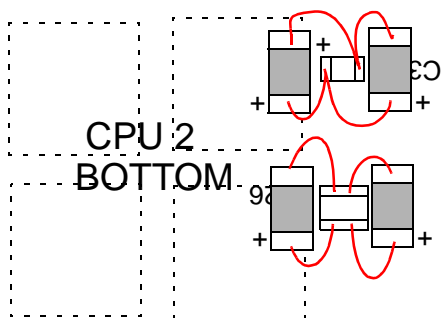
With Tantalum caps:

Errata 46: CPU2 Power Supply Fix

Lack of bypass capacitors on one side of CPU #2 limits Fmax.

1. Add capacitors across C126 and C310 on the bottom of the board beneath U2. Connect either:

B) four 470 uF 6-10V tantalum capacitors.

2) Connect as shown for either type, observing capacitor polarity.

A) C126 ground is to the right/toward the PCI slots.

B) C310 ground is towards the bottom (toward U1).
