Sandpoint Reference Platform Errata

Board Revision Level	X2
Errata Revision Level	G

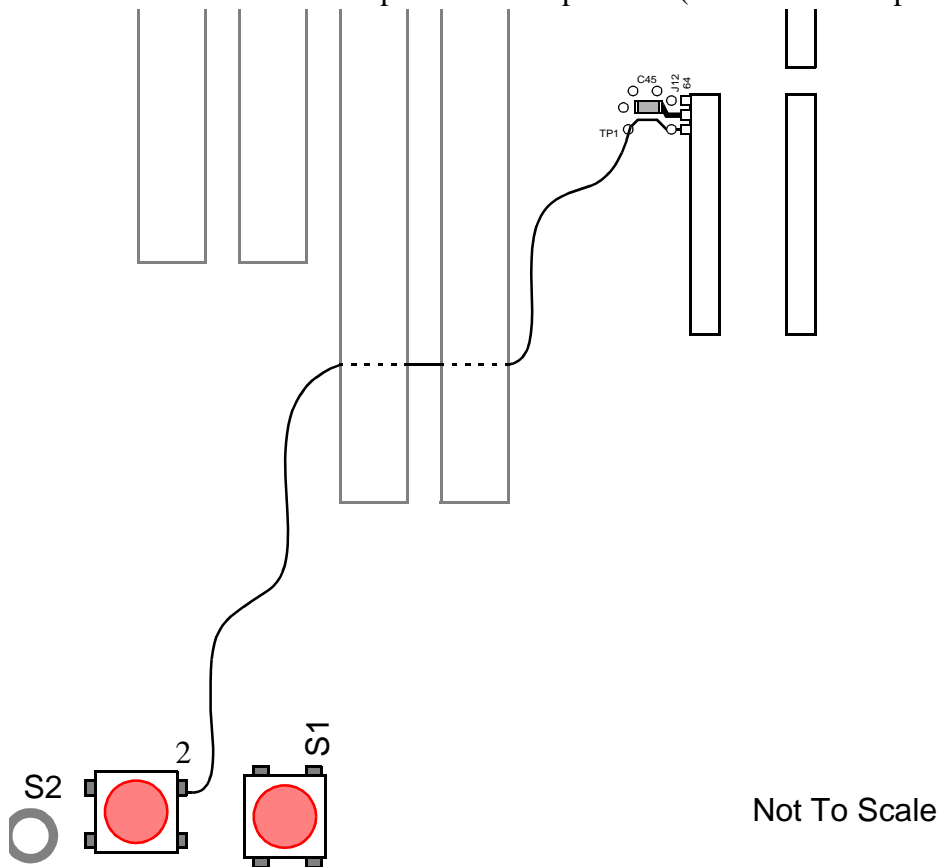
Errata 7: Target System Reset

COP in-circuit emulators may not be able to reliably gain control of the target system if the reset command issued to the PPMC card does not also reset the motherboard (Sandpoint). The cause is apparently due to interrupting a PCI transaction the Winbond before completion. If the Winbond is not reset, the system will lock up until a global reset is issued.

The latest VITA specification has added a pin to the PPMC connector for just such a purpose. The rework adds this function.

The work-around is to connect the new SYSRST* function to the reset switch pin.

1. Connect a wire to pin 2 of S2 to pad TP1 (connects to J12 pin 60).

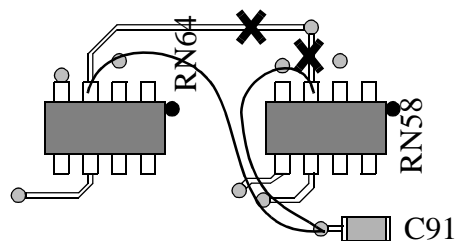
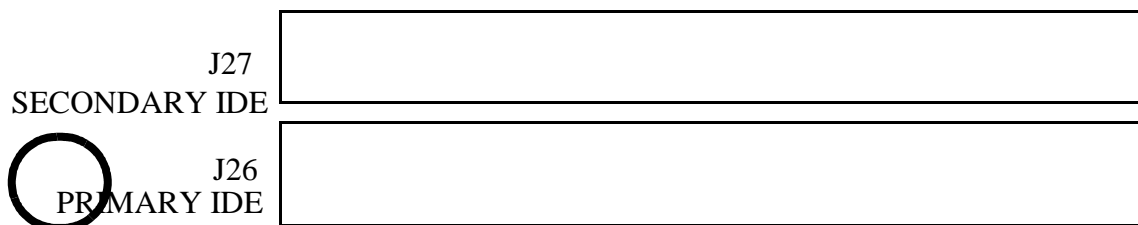
Errata 10: IDE IOCS16* FIX

The ISA signal IOCS16* is connected to the IOCS16* pin of the IDE disk drive cables. This can cause problems with interactions between the Winbond PIC and the IDE disk controller during periods of heavy interrupt activity, depending upon the nature and timing of interrupts.

The failure is intermittent but repeatable on certain OSs, the exact nature of the problem is under investigation.

The work-around is to permanently wire IOCS16* to ground, putting the device in 16-bit transfer mode.

1. Cut trace between RN58 pin 3 and via.
2. Connect RN58 pin 3 to C91 left side or to via.
3. Cut trace between RN64 pin 3 and via.
4. Connect RN64 pin 3 to C91 left side or to via..
