Error Correcting Codes Implemented on MPC55xx and MPC56xx Devices

Intention of this application note is to describe how ECC protection is implemented with MPC55xx and MPC56xx devices and understand particular MCU's ECC event response. It also offers some software examples for illustration of mentioned behavior.

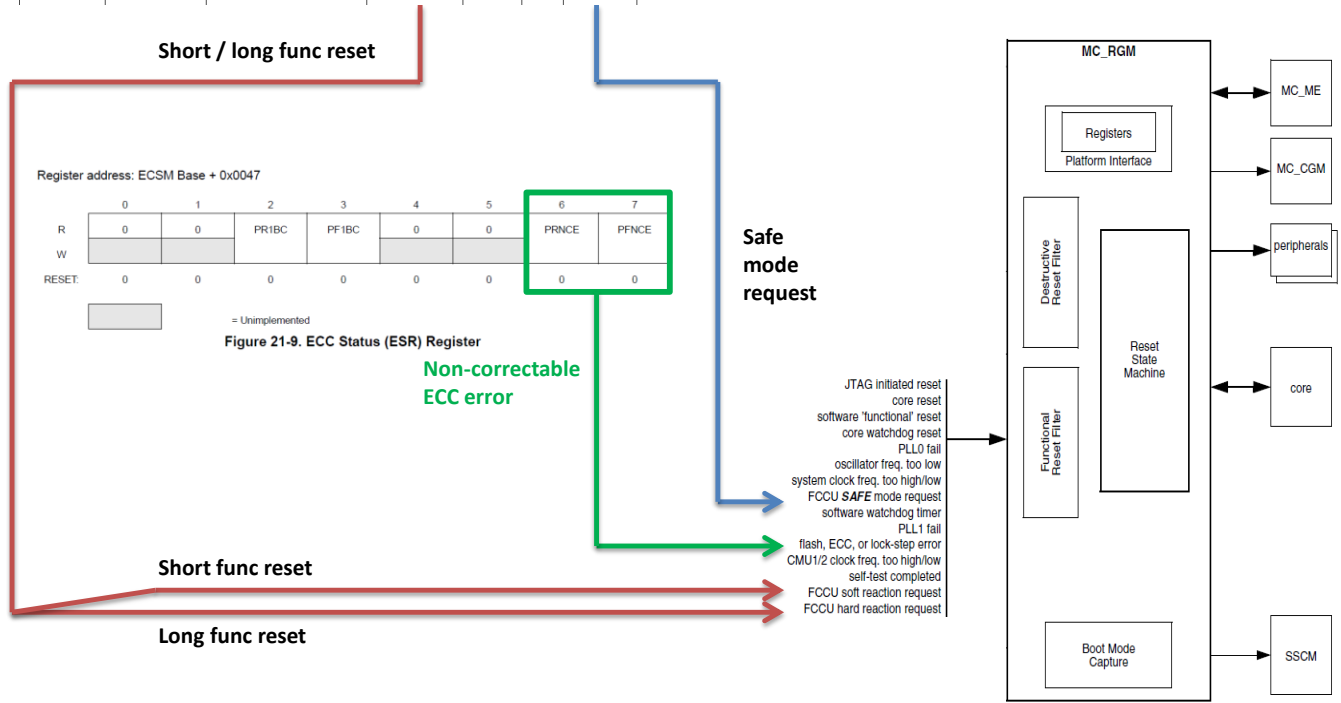
Figure 1. Reset Generation Module reporting on MPC564xL

This section is related only to MPC564xL and MPC567xK devices and describes their specific implementation. ECC error is now also reported to FCCU and RGM modules as shown in the [Figure 1](#). ECSM detection of multibit ECC error also cause FCCU critical faults CF16 and CF17.

Figure 787. MC_RGM block diagram

If RGM_FERD[D_FL_ECC_RCC] = 1, ECC double bit error generates safe mode request and device goes to machine check exception. However this machine check is invoked two times, firstly by Read Bus Error, secondly by FCCU non-maskable interrupt (delay between this two events is not precisely defined as Core and FCCU module are driven by different and independent clock sources). Multiply IVOR1 issuing cause loosing of returning address (MCSRR0) thus this exception is non-recoverable and application must be reset anyway by software reset.
