# ERRATA SHEET

**Date:** September 17, 2002  
**Document Release:** Version 1.1  
**Devices Affected:** P89C660, P89C662, P89C664, P89C668  
(referenced to as P89C66x in this document)

# On-chip Flash 8-bit microcontroller

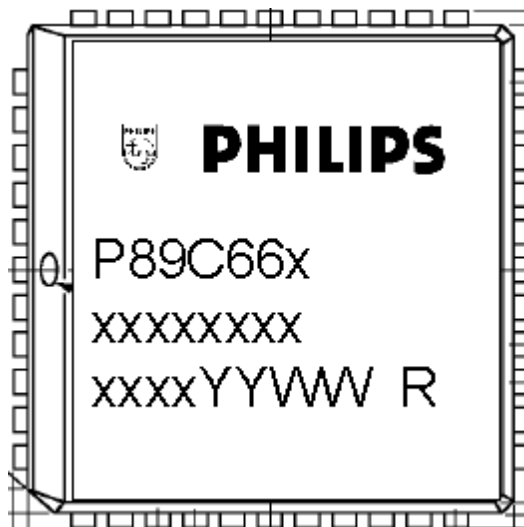
The P89C66x devices have the following top-side marking (PLCC44 package shown):

The last letter in the third line (field 'R') will identify the device revision. This Errata Sheet covers the following revisions of the P89C66x:

Field 'YY' states the year the device was manufactured. Field 'WW' states the week the device was manufactured during that same year.
