# ERRATA SHEET

**Date:** June 24, 2002  
**Document Release:** Version 1.0  
**Devices Affected:** P89C660, P89C662, P89C664, P89C668  
(referenced to as P89C66x in this document)

On-chip Flash 8-bit microcontroller  
Errata Sheet

P89C66x

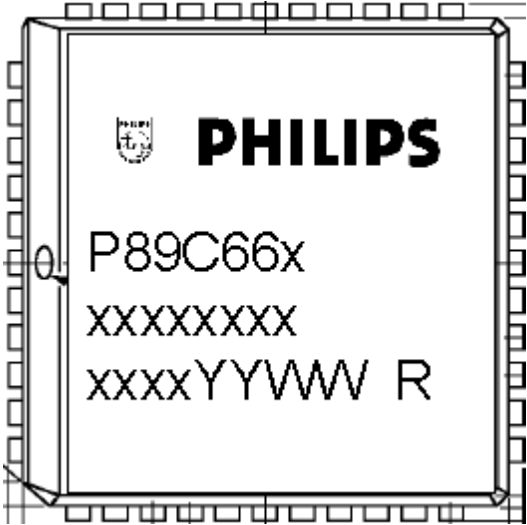
The P89C66x devices have the following top-side marking (PLCC44 package shown):

The last letter in the third line (field 'R') will identify the device revision. This Errata Sheet covers the following revisions of the P89C66x:

Field 'YY' states the year the device was manufactured. Field 'WW' states the week the device was manufactured during that same year.
