## Test Report

No. SHAEC2216667818

Sample Name : QMI538NB

Sample Description : Adhesive

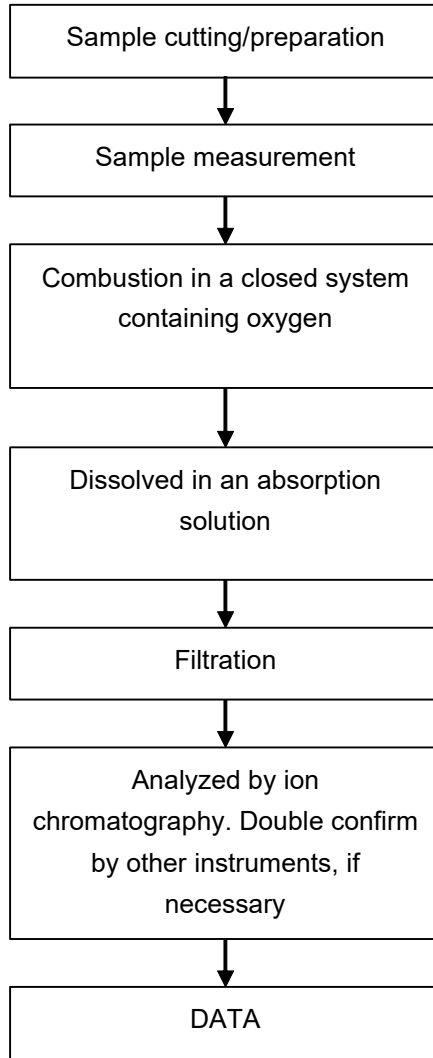
### Halogen Testing Flow Chart

Test Method : With reference to BS EN 14582: 2016, analysis was performed by IC.
